Olympian is a Condominium located on Bainbridge Island, WA with three residential buildings. The association was incorporated 38 years ago, in 1978.

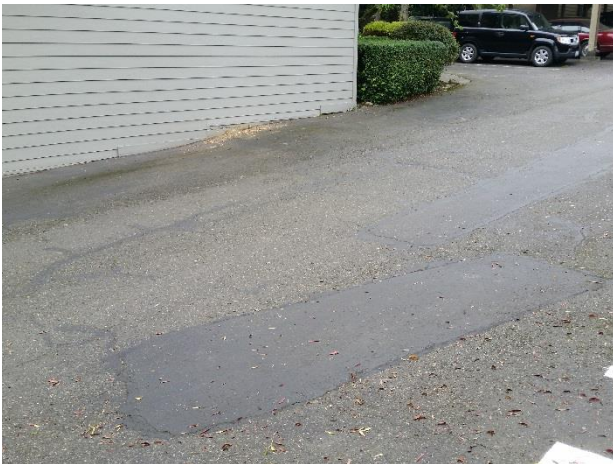
Asphalt was failing, grades were sloped incorrectly causing water to flood landscaping and thereby increasing the risk of water intrusion into below grade units, and the parking areas did not have a proper ADA space.

Numerous areas had been patched.

Remove asphalt and re-grade areas to move water away from the buildings to prevent pooling and flooding into walkways. Channel water correctly into storm drains. Install new 2" asphalt.

Saw-cut and remove degraded areas. Fill these areas with 2" asphalt. Overlay remaining areas with 1 1/2" asphalt.

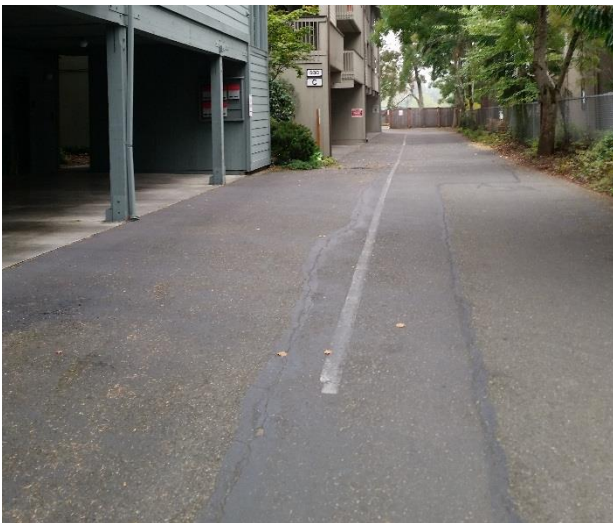
Drain work was completed, leaving additional patches.

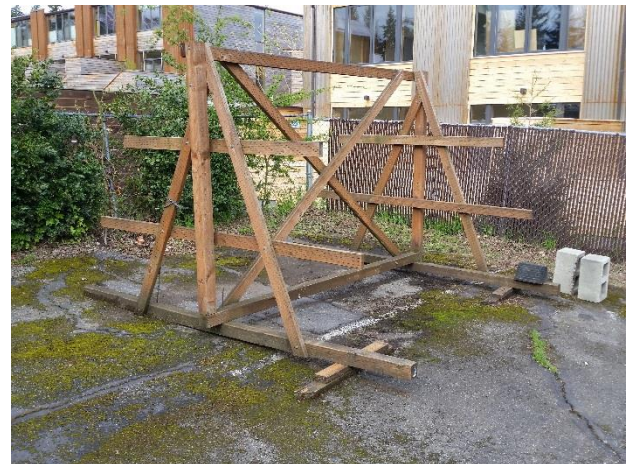
Kayak rack takes two valuable parking spaces.

An alternate location for kayaks was identified and a new one built; it is already in use.

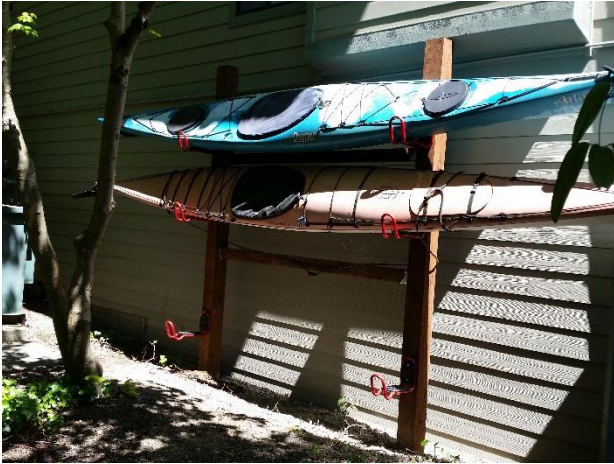
New kayak rack.

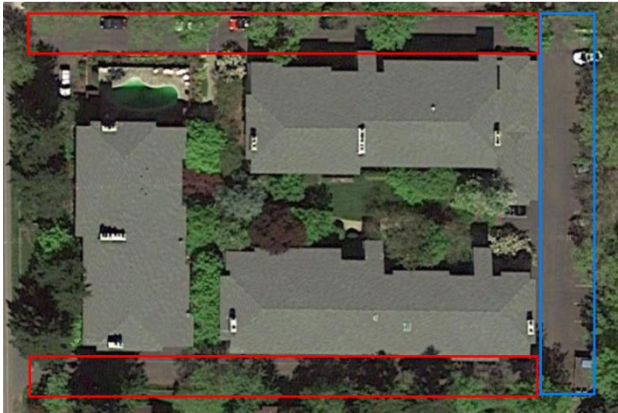
The striping layout was designed to maximize the parking spaces and to designate areas for parking, no parking, ADA, etc.

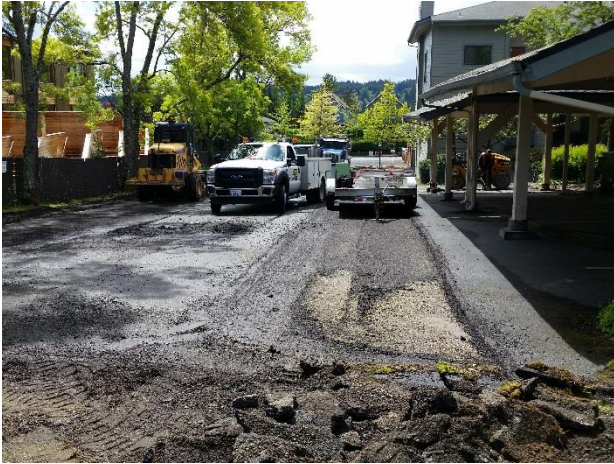
Removal of asphalt.

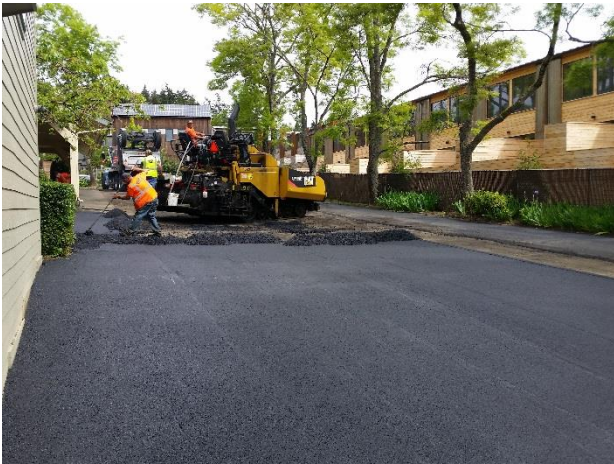
New asphalt installation.

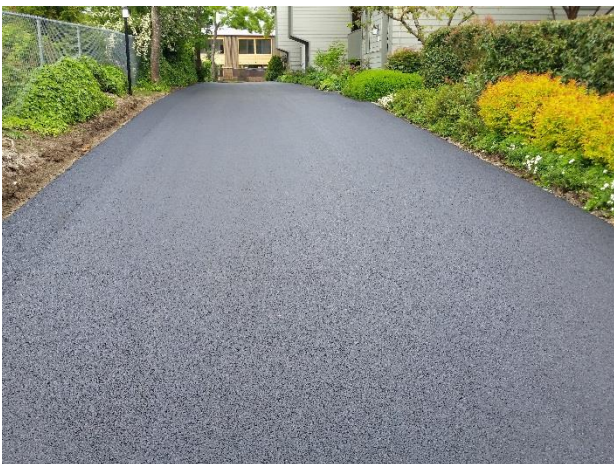
Asphalt completed and includes rolled-up edges to channel water.

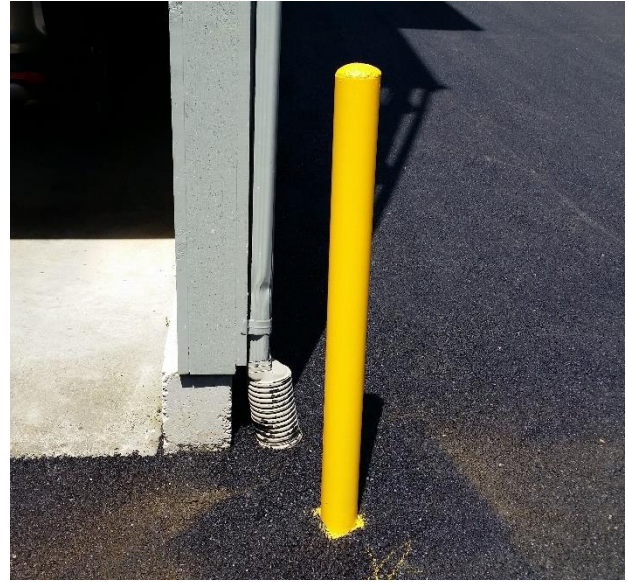
Bollard installed by Lakeside Industries and painted by Quality Coating protects the building wall and downspout against vehicle damage.

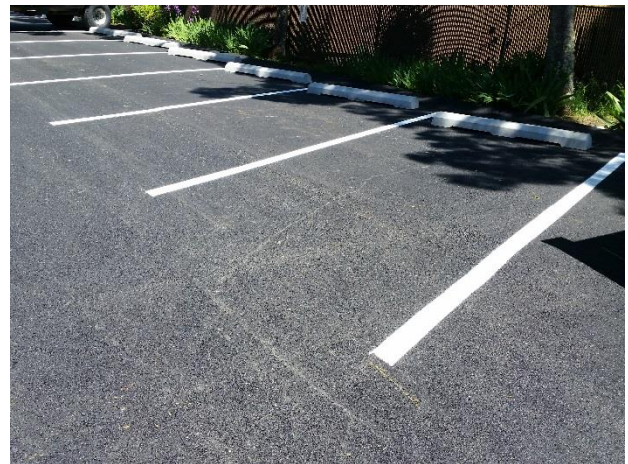
New angled-parking and wheel stops.

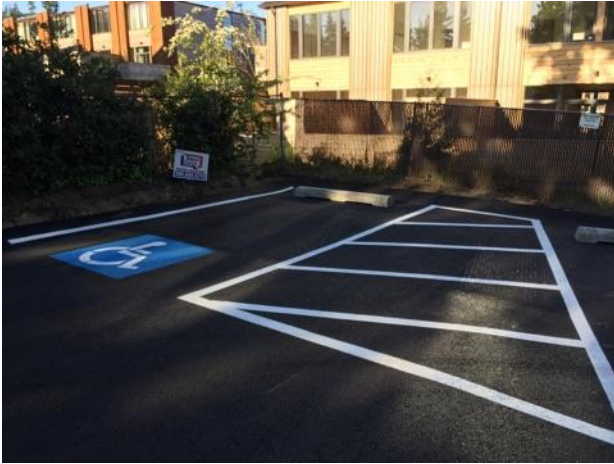
New ADA stall.

A large tree was removed near the ADA location and the area was graded to comply with slope, size and other requirements.

Striping clearly identifies the location, and access is convenient.

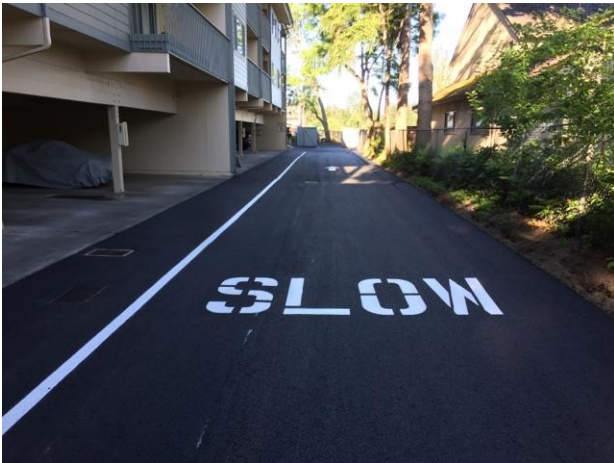
Drive lane and SLOW demarcated.
